**Flood Control Project Maintenance  
Levee Inspections**  
**LMA District Cover Sheet**  
**Spring 2010 Levee Inspection Results**

**Lake County Watershed Protection District**

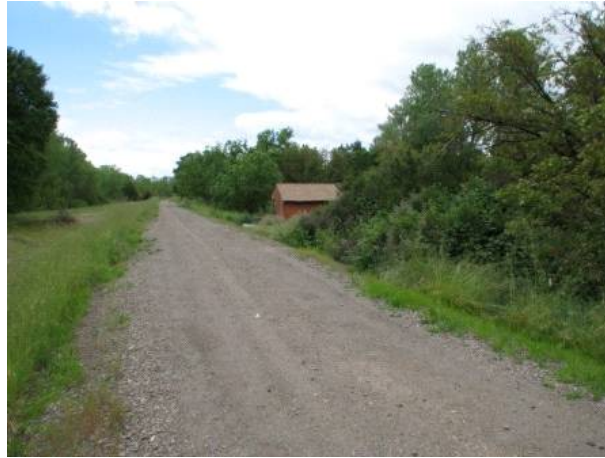
rduffey\_s\_20100616\_044.jpg

LMR No	Levee Mile		Category	Item	Location *	Rating **	Action/Comment	GPS Latitude/Longitude		Issue No. Photo
	Start	End						Start	End	
1	0.20	0.20	Earthen Levee	Encroachments	LS	CO	Buildings	39.187039 ° -122.908880 °	39.187039 ° -122.908880 °	1 Y
2	1.03	1.04	Earthen Levee	Vegetation	LS	M	Remove the wild growth other than native grasses from the levee slopes.	39.177218 ° -122.913673 °	39.176992 ° -122.913642 °	7
3	1.05	1.05	Earthen Levee	Encroachments	LS	PO	Buildings	39.176875 ° -122.913685 °	39.176875 ° -122.913685 °	5

Levee Mile Report Line	1
Start Levee Mile	0.20
End Levee Mile	0.20
Location	Land Side
Category	Earthen Levee
Item	Encroachments

View of the vegetation and building next to the landside toe of levee.

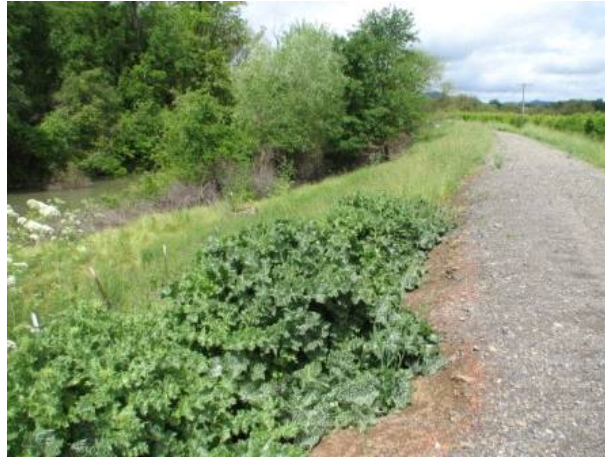
rduffey\_s\_20100616\_045.jpg

LMR No	Levee Mile		Category	Item	Location *	Rating **	Action/Comment	GPS Latitude/Longitude		Issue No.
	Start	End						Start	End	Photo
1	0.91	0.99	Earthen Levee	Vegetation	WS	M	Control annual grass and weeds on the levee slopes and easements.	39.159733 ° -122.921081 °	39.160088 ° -122.922590 °	1 Y

Levee Mile Report Line	1
Start Levee Mile	0.91
End Levee Mile	0.99
Location	Water Side
Category	Earthen Levee
Item	Vegetation

View of the vegetation along the water side slope of the levee.

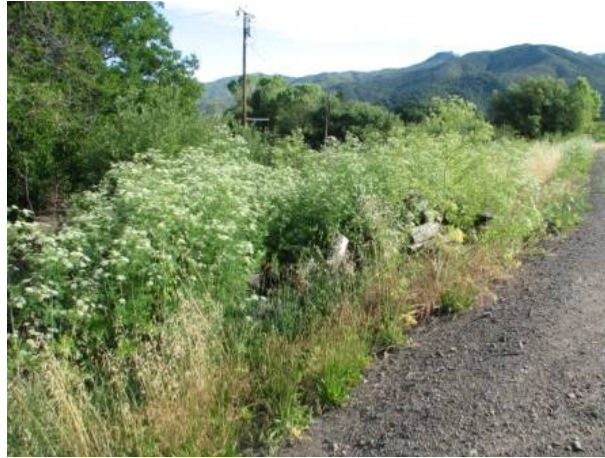
rduffey\_s\_20100625\_079.jpg

LMR No	Levee Mile		Category	Item	Location *	Rating **	Action/Comment	GPS Latitude/Longitude		Issue No. Photo
	Start	End						Start	End	
1	0.90	0.90	Earthen Levee	Encroachments	LS	M	Garbage	39.178545 ° -122.896648 °	39.178545 ° -122.896648 °	1 Y
2	1.05	1.18	Earthen Levee	Trim / Thin Trees	LS	M	Trim trees to at least five feet above ground level.	39.180479 ° -122.896567 °	39.181947 ° -122.895112 °	2
3	1.41	1.41	Earthen Levee	Trim / Thin Trees	LS	M	Thin trees to allow visibility of the ground and room to flood fight.	39.184842 ° -122.893368 °	39.184842 ° -122.893368 °	3

Levee Mile Report Line	1
Start Levee Mile	0.90
End Levee Mile	0.90
Location	Land Side
Category	Earthen Levee
Item	Encroachments

View of the garbage and wood on the landside slope of the levee.

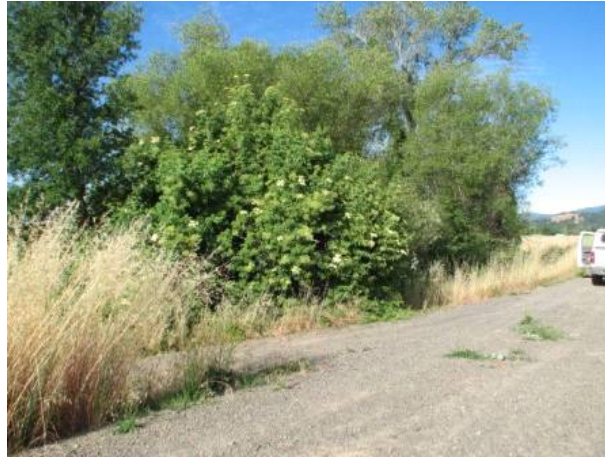
rduffey\_s\_20100625\_080.jpg

LMR No	Levee Mile		Category	Item	Location *	Rating **	Action/Comment	GPS Latitude/Longitude		Issue No. Photo
	Start	End						Start	End	
1	0.30	0.30	Earthen Levee	Vegetation	LS	M	Elderberries are blocking visibility and flood fight capability.	39.176957 ° -122.898673 °	39.176957 ° -122.898673 °	3 Y

Levee Mile Report Line	1
Start Levee Mile	0.30
End Levee Mile	0.30
Location	Land Side
Category	Earthen Levee
Item	Vegetation

View of the elderberries along the landside toe of the levee.
